Delta T Inspection Services of Iowa

Property Inspection Report

, Anytown IA
Inspection prepared for: Harry Homeowner
Inspection Date: 2/14/2010 Time: 1:00pm
Age: 41yrs Size: 1250sqft
Weather: clear/23F

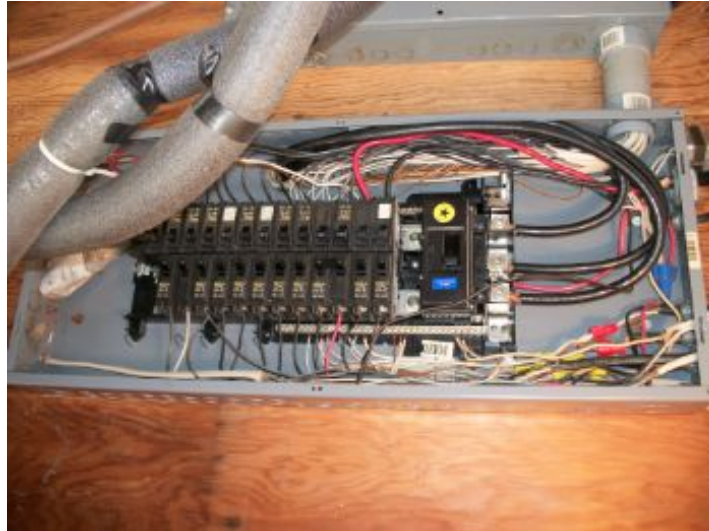
- No major system safety or function concerns noted at time of inspection at main panel box.

Electrical panel cover removed

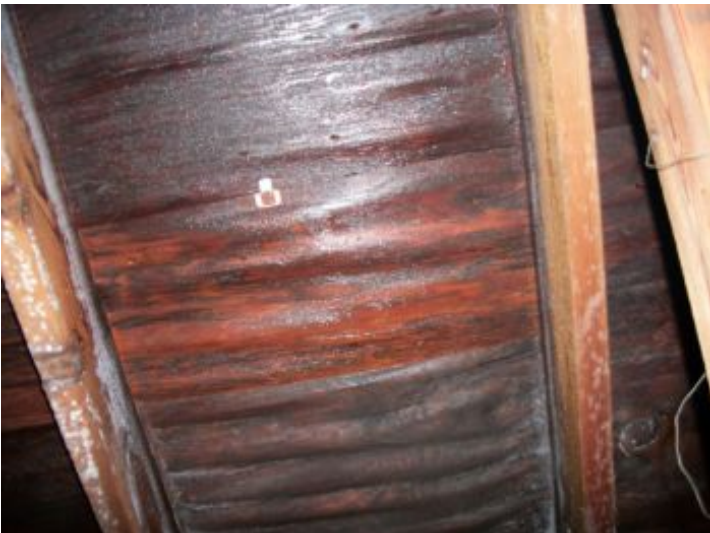
- Snow covered; not fully inspected.
- Some shingles damaged.
- Some shingles curling.
- Sagging / buckling on roof decking.
- The north facing roof on the west end of house appears to be dipping in towards attic. See pic.

Looking up through attic access shows that all visible sheathing is wet. This moisture is throughout the entire roof structure and penetrating to the rafters. This is a potentially dangerous situation if not addressed ASAP

Wet roof sheathing

- recommend roofing contractor to evaluate

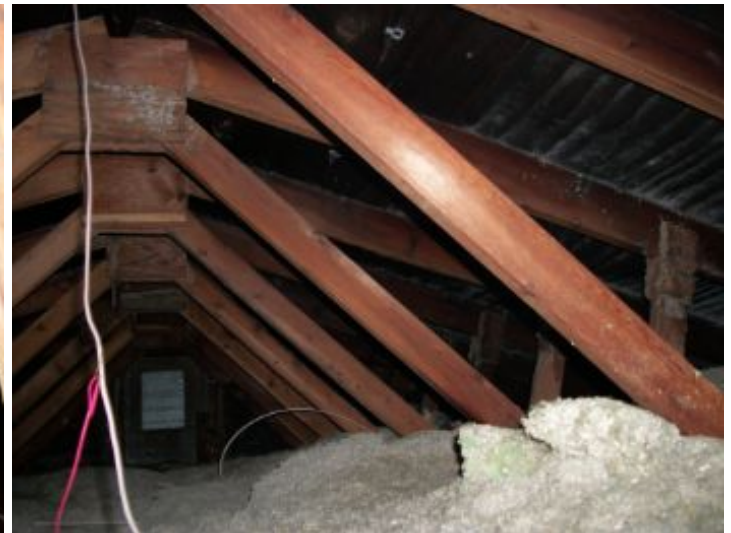
More wet roof sheathing and frost accumulation

- Gable louver vents noted.
- Frost observed at underside of roof.
- Recommend review for repair or replacement as necessary.

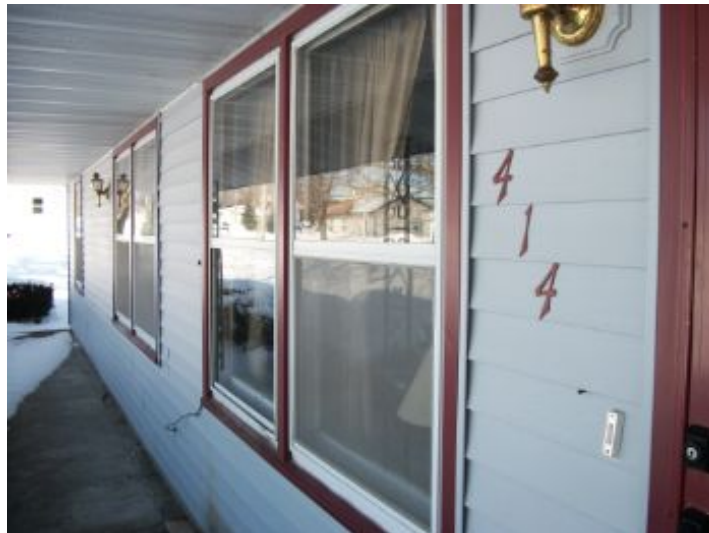
- Some window screens damaged.
- Window pane not secure; needs glazing
- In the inspectors opinion the windows/frames are near the end of their useful life.
- Metal frame windows are subject to frost and condensation and require regular maintenance for proper operation.
- Recommend review for repair or replacement as necessary.
- Windows in this home do not meet modern standards. Upgrade would greatly enhance overall comfort and efficiency.

Single pane old windows missing glazing
